EXTREME CONDITIONS – INNOVATIVE & SUSTAINABLE  
SOLUTIONS IN MURAL PAINTING CONSERVATION

# BOOK OF ABSTRACTS

INTERNATIONAL CONGRESS ON MURAL  
PAINTING CONSERVATION

EXCISS 2025

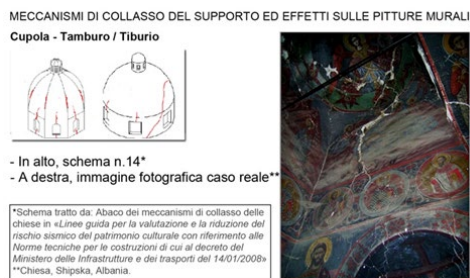
Figure 1. Collapse mechanisms of the support and effects on mural paintings: dome – drum / lantern. The sheet is obtained by combining some graphic diagrams taken from “Abaco dei metodi di collasso delle chiese” in Guidelines for the evaluation and reduction of seismic risk of cultural heritage with photographic images of real cases in the presence of wall paintings.

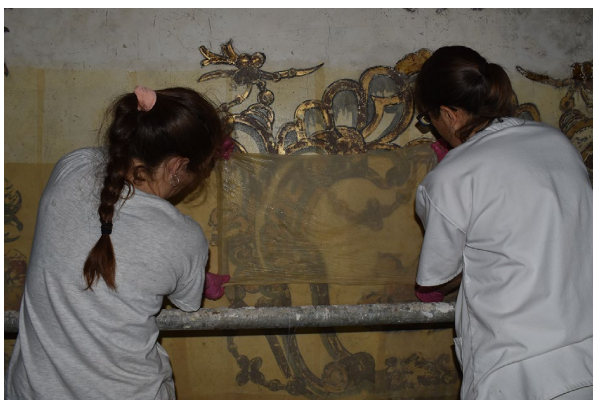
Figura 2. Aplicación de la retorta. Arranque de las pinturas murales de una de las capillas de la Iglesia de los Santos Juanes de Valencia.

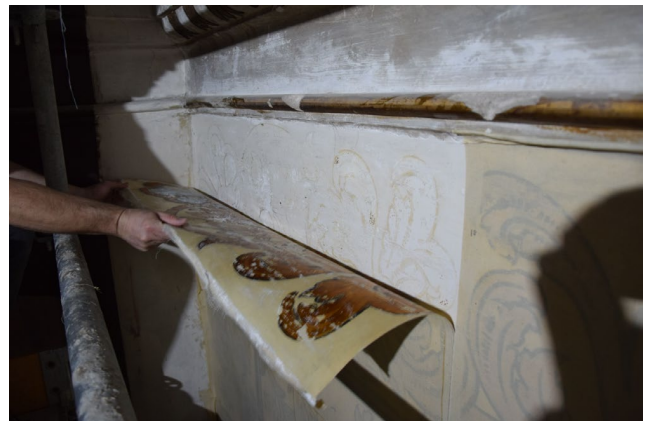
Figura 3. Extracción del muro. Arranque de las pinturas murales de una de las capillas de la Iglesia de los Santos Juanes de Valencia.

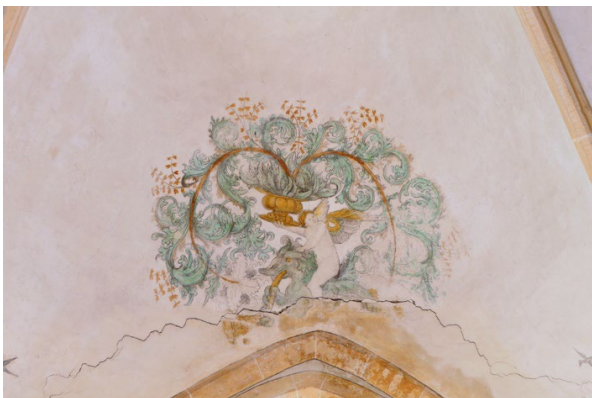
Figure 1. Crack in the painting caused by an earthquake at Hippolytus Church, Middelstum. Photo credits: [OUOU](#).

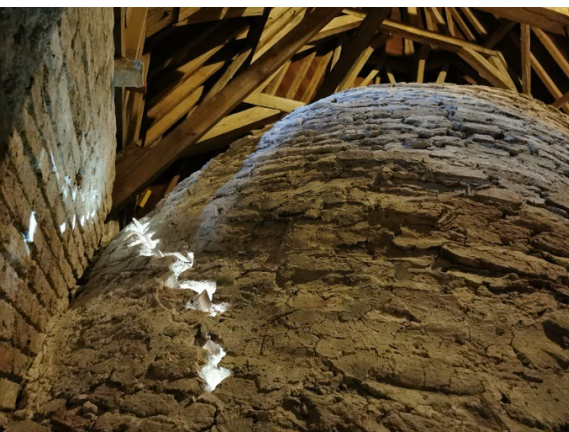
Figure 2. A crack in the vault, Hippolytus Church, Middelstum. Photo credits: [OUOU](#).

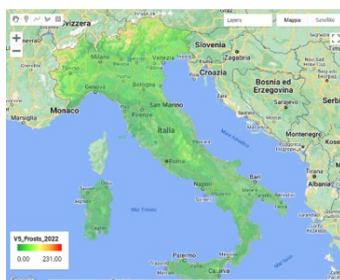
Figure 2. Example of frosts map for Italy for the year 2022, obtained with Art-Risk 5 [4].

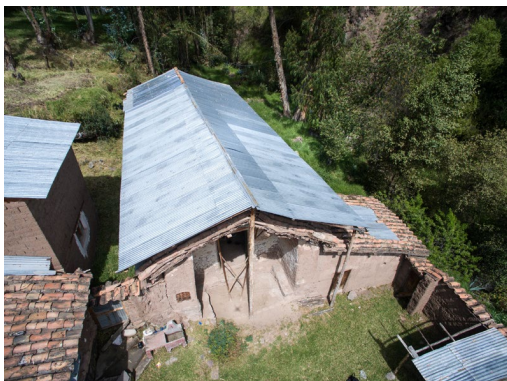
Figure 1. Temporary cover structure to prevent water leaks caused by rain. Source: Own photographs.

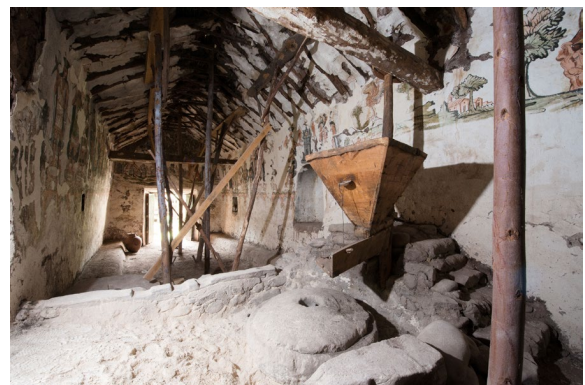
Figure 3. Pair and knuckle in poor maintenance conditions, which causes leaks, humidity that affects and induces discoloration and loss of pictorial layers). Source: Own photographs..

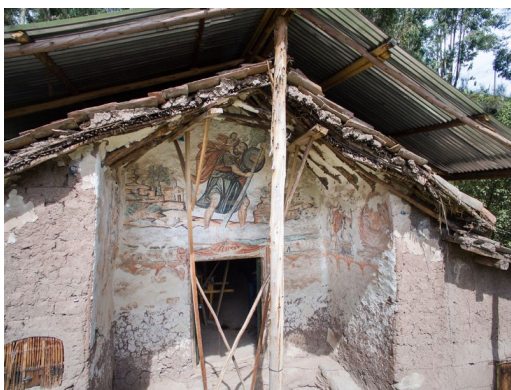
Figure 2. Mural paint on a façade with detachment pathologies produced by direct exposure to environmental factors. Source: Own photographs.

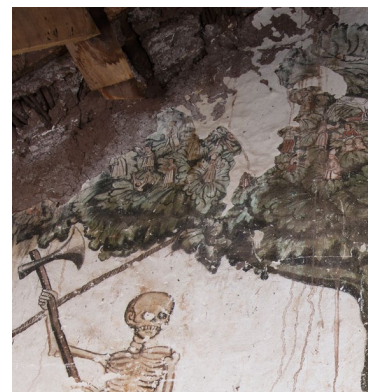
Figure 4. Evidence of presence of xylophages and humidity that destroy lime plaster and wall paint. Source: Own photographs.

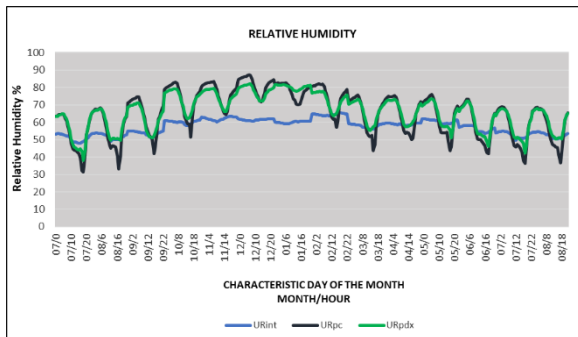
Figure 1. Graph of relative humidity in the lodge during the monitoring period.

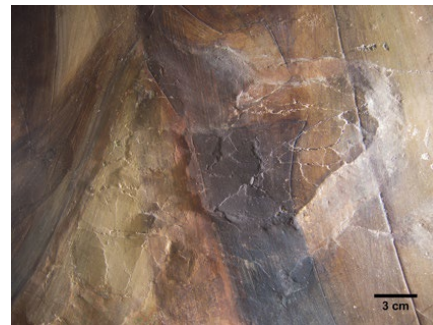
Figure 3. Detail taken in raking light of the damage caused by the detachment of the wall painting.

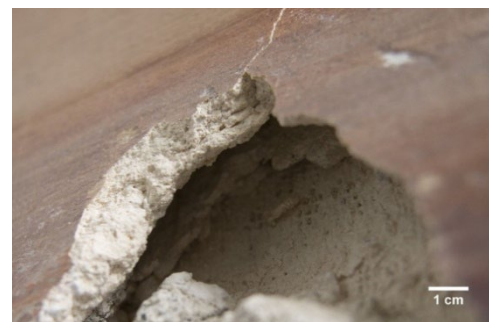
Figure 4. Detachment of the original plaster layers. The open-weave fabric introduced as a primary support can be seen on top of the polyurethane expansive foam. The grout developed needed to address all these issues.

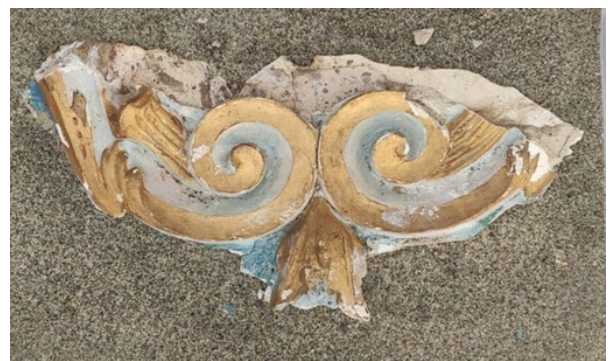
Figure 4. Condition of the surface after the removal of the menthol.

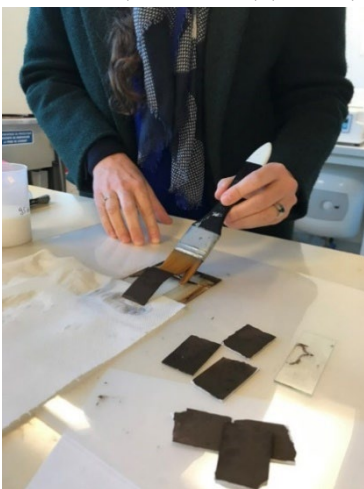
Figure 2. Application of the consolidation treatment on the painted surface of the deformed gypsum samples (©LRMH, M.Tiennot).

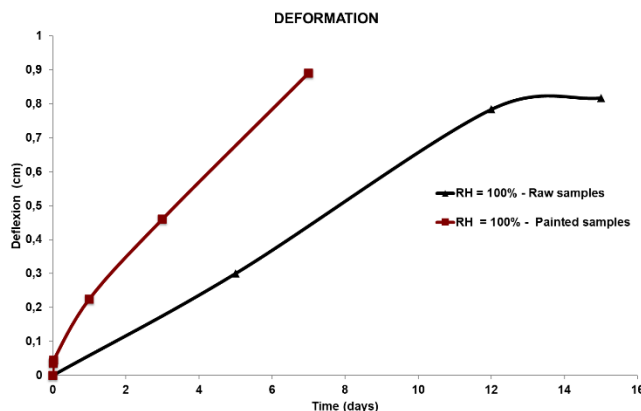
Figure 3. Macroscopic deformation of the samples during the three-points flexural creep tests, during the deformation phase at RH=100%, for raw and painted samples

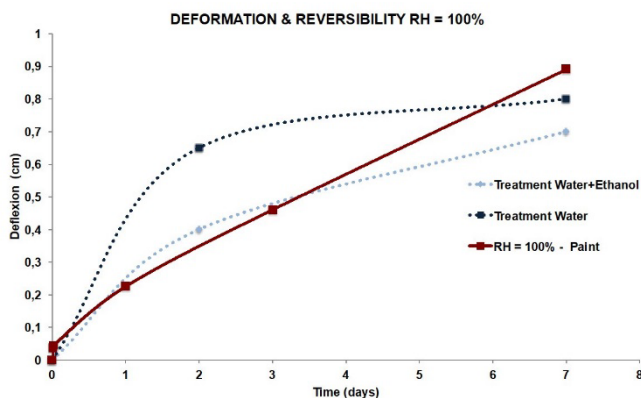
Figure 4. Macroscopic deformation of the two sets of consolidated samples during the three-points flexural creep tests, during the recovery

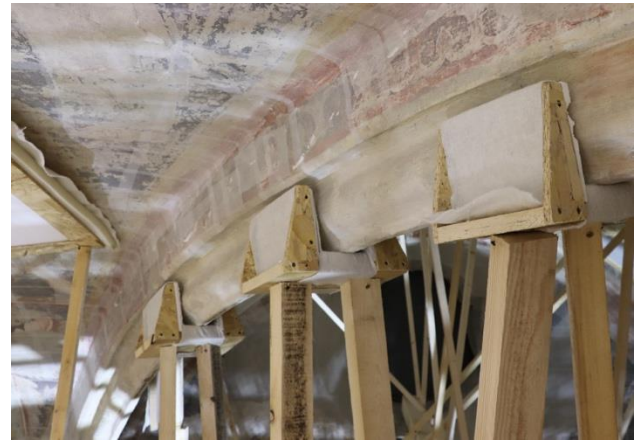
Figure 3. Protection of the wall paintings.

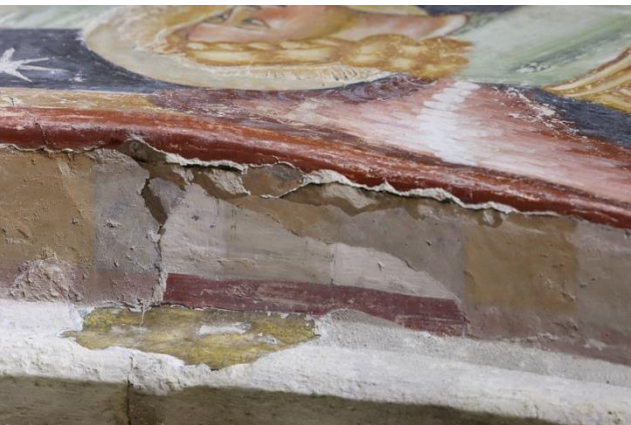
Figure 2. Detail of the damages on the wall paintings caused by the earthquake.

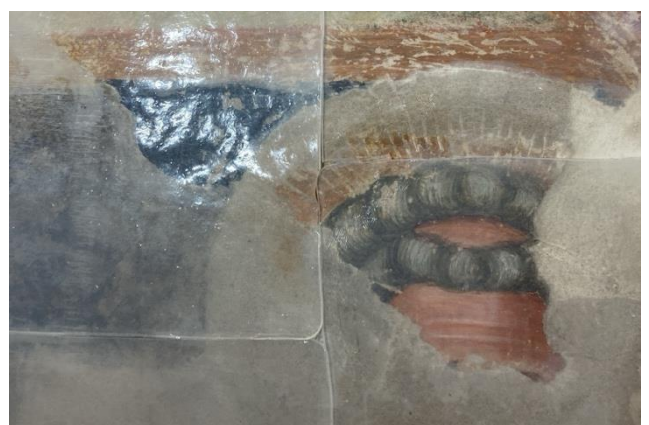
Figure 4. Agar-agar plates for the facing removal.

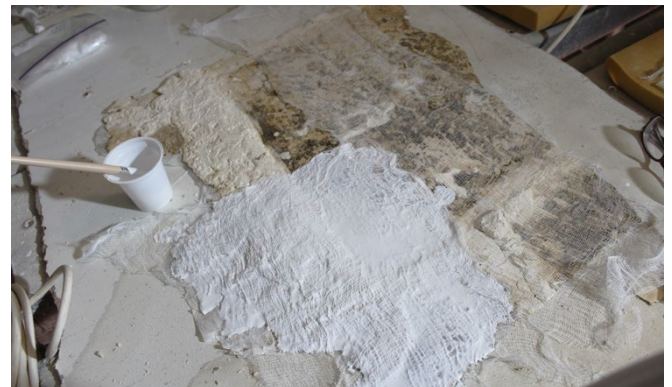
Figure 3. Application of calcium caseinate reinforced with gauze.

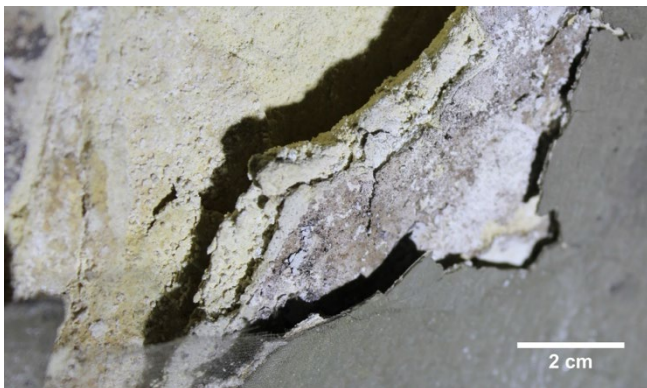
Figure 2. Delamination of the stone extending to the paint layers.

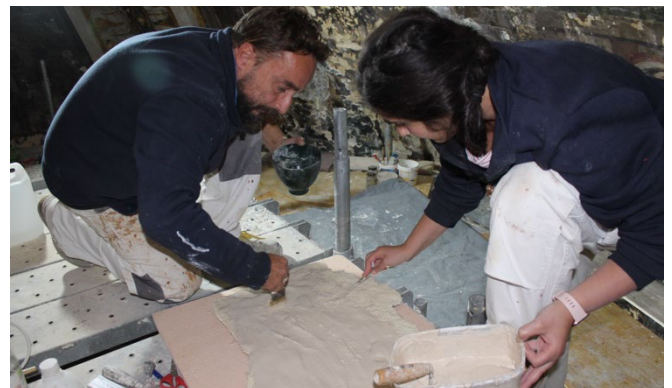
Figure 4. Applying a thick grout on the back of the reinforced.

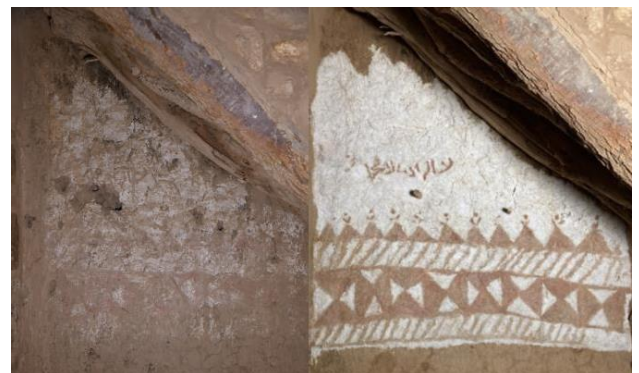
Figure 4. Wall painting under a staircase before and after the conservation treatment
